A case study on deterioration assessment and rehabilitation of fire damaged reinforced concrete structure

Ojha P N, Brijesh Singh*, Adarsh Kumar N S, Abhishek Singh, Vikas Patel

National Council for Cement and Building Materials, India.

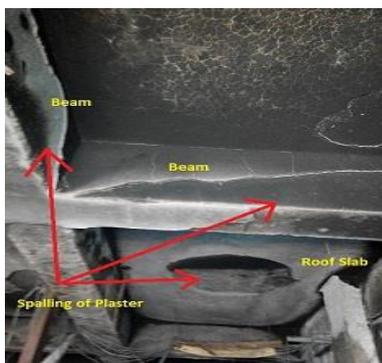
In order to take up the research project on fire damaged structures, during the preliminary site investigation it was observed that the fire has occurred at the fifth floor room of the building and its fumes/gases escaped through the duct opening in the roof slab to mezzanine floor at the top. The spalling of plaster from roof slab, beams and columns had occurred at several places (refer Fig. 1-2). No documents or drawings other than a basic plan view of the arrangement of rooms on the floors was available. No details regarding the structural design or mix design of concrete were available. Accordingly the authors decided to categorize the various investigation studies in two parts i.e. field investigation and laboratory investigation. The field investigation covered (i) determination of Quality of concrete using UPV testing technique as per IS: 13311 (Part – I) - 1992, (ii) Concrete cover study and (iii) extraction of concrete cores samples from identified members for Carbonation study at site and to further carry out the laboratory investigation on concrete cores, which covered (a) Determination of equivalent cube compressive strength of concrete core as per IS 456 (2000) & IS:516(1959) (b) Chemical analysis of hardened concrete to determine pH value, chloride content and Sulphate content.

Fig. 1. Spalling of Plaster in Beams & Slabs

- i) Removal of all cracked and loose cement plaster from the Reinforced Cement Concrete members and walls in fire damaged area by chiseling out surface concrete up to 20mm depth in deteriorated structural elements and to remove the existing plaster over the wall also.

- ii) Applying bond coat of SBR (Styrene Butadiene Rubber) latex based polymer modified cement slurry in proportions 1:1 (1 cement: 1 polymer) to be applied on the prepared surfaces of concrete/substrate.

- iii) To rehabilitate roof slab soffit, Columns and Beams by building up the profile of structural members up to 40 mm average depth & 20 mm average thickness in walls by Polymer Modified Mortar (PMM) using emulsified SBR latex conforming to ASTM C-1059 (2013) Type-I in damaged areas (1 Cement-3 part graded cleaned river sand + 15 % latex by weight of cement) with 0.35 w/c ratio, in 10-15 mm thick layers by applying bond coat between successive/each layers including leveling and profiling complete. Proper curing to be done for the repair work. Gunny bags to be used for effective curing. Polypropylene fibres to be added to reduce shrinkage.

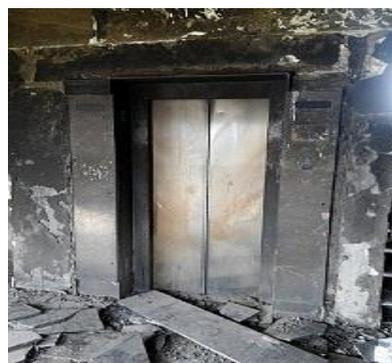
Fig. 2. View of lift lobby in fire damaged area

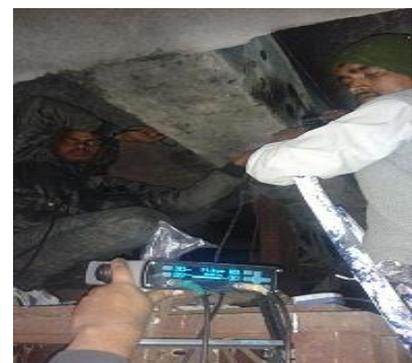
Measurements were taken by direct method (cross-probing) as shown in fig.3. Based on Ultrasonic Pulse Velocity obtained, the overall quality of concrete was graded as 'Good'.

Fig. 3. UPV Measurement being recorded

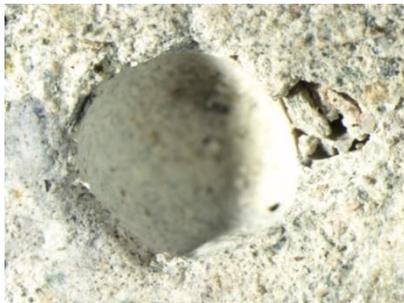
Fig. 4. C-32-Bottom-1: Voids filled with crystalline material

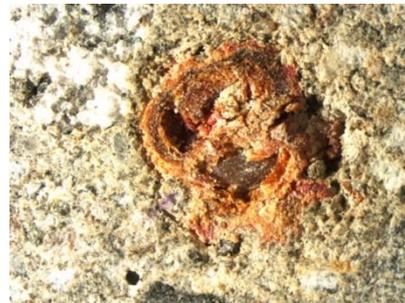
Fig. 5. -1-Middle-2: Leached out materials as observed in the sample

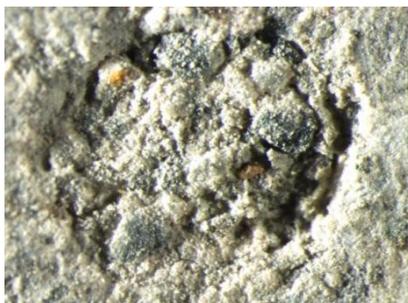
Fig. 6. S-6-Middle-3: Voids filled with crystalline material

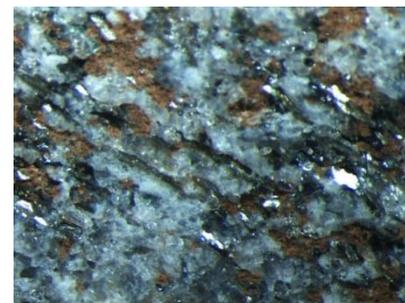
Fig. 7. S-6-Bottom-3: Stretching of coarse and fine aggregate due to temperature rise

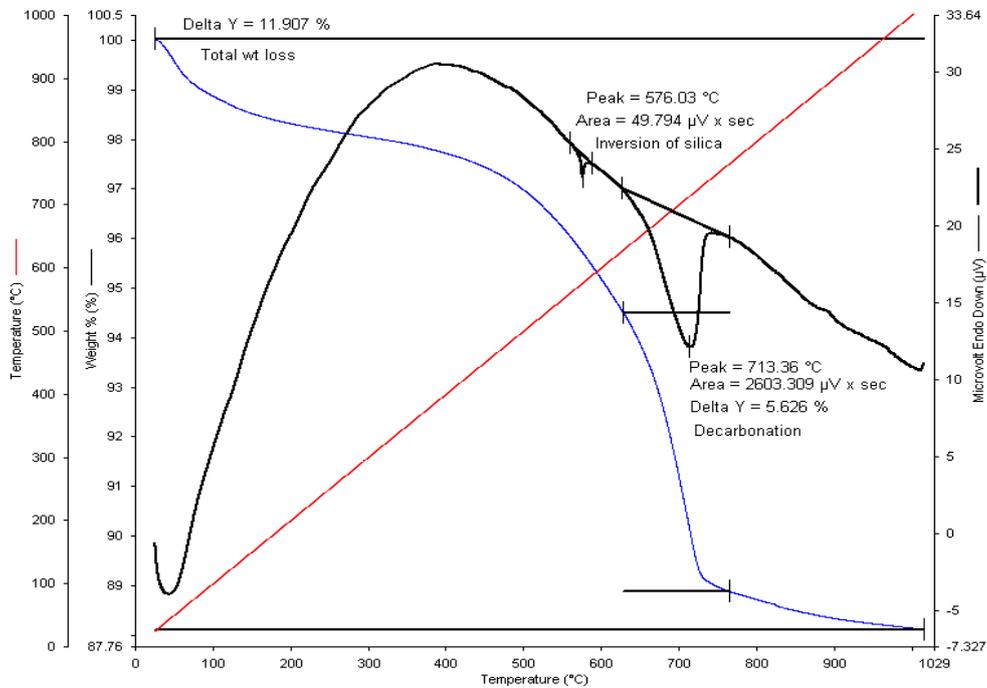
The samples from identified locations covering Plaster from Beam B8 & Beam B32 and sliced concrete cores in layers (0-20mm), (20-40mm) & (40-80mm) from Beam B8 and Slab S1, were grinded to powder passing 150 micron IS sieve. The Differential Thermal Analysis was carried out to assess weight loss corresponding to different temperatures. In sample of Beam-B8 Plaster, the total weight loss of 11.91 percent for (0-20mm) depth up to a temperature of 1000°C from ambient@ 10°C/minute. Graph for Beam B8 Plaster (0 - 20mm) shown in fig. 8. In Beam-B32 Plaster, the total weight loss of 11.069 percent for (0-20mm) depth up to a temperature of

Fig. 8. Graphical Representations of study on plaster samples from Beam B8 of fire damaged area

In general, the results of DTA analysis done on all samples show that, the first endothermic peak occurred at around 430°C was due to dissociation of calcium hydroxide. Inversion of silica

occurred at around 575°C and was represented by a small sharp endothermic peak. The third endothermic peak was occurred at around 750 °C due to decarbonation. Where effect of fire was negligible, peak due to dissociation of $\text{Ca}(\text{OH})_2$ was absent in the DTA curve at 0-5 mm depth whereas it was present in the DTA curves at greater depths. This indicates that at 0-5 mm depth, the peak was absent because of carbonation of concrete (measured depth of carbonation front was found to be maximum 10 mm) and not due to exposure to elevated temperatures due to fire. As carbonation had not progressed beyond this depth, the peaks corresponding to dissociation of $\text{Ca}(\text{OH})_2$ were present in the DTA curves at greater depths.

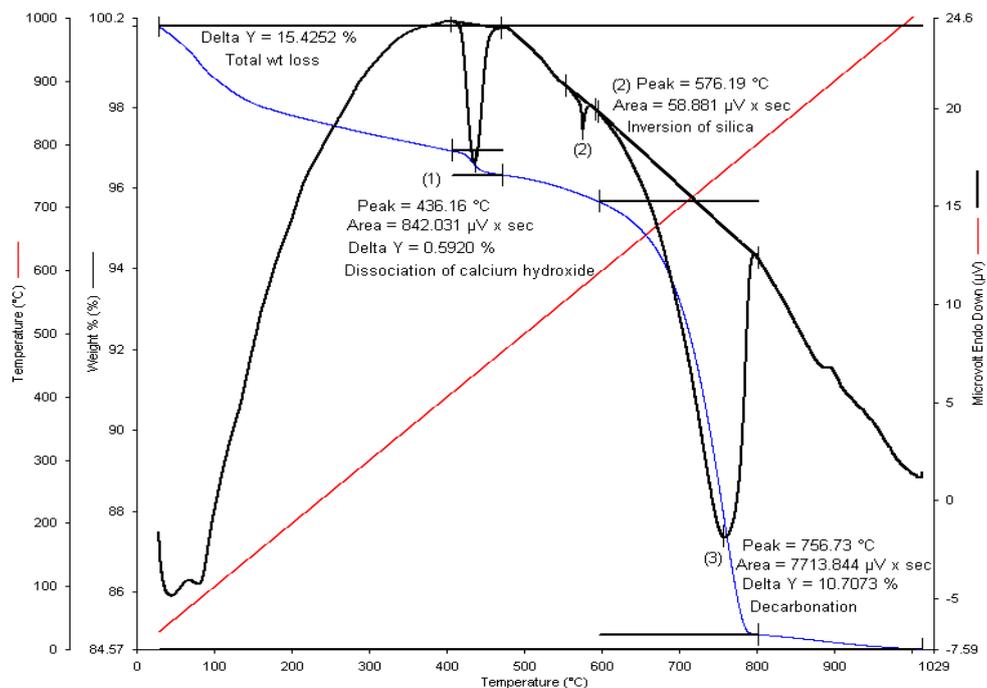
1000°C from ambient@ 10°C/minute was observed. In sample from Slab S1, the total weight loss of 15.42 percent for (0-20mm) depth, 15.16 percent for (20-40mm) depth and 13.82 percent for (40-80mm) depth up to a temperature of 1000°C from ambient@ 10°C/minute was observed. Graph for Slab S1 (0 - 20mm) is given in Fig. 9.

Fig. 9. Graphical Representations of study on concrete samples from Slab S1 of fire damaged area
