Rehabilitation of existing building structure in expansive soils: A case study in Laghouat, Algeria

Abstract. This work presents results obtained from a case study conducted on M'kam neighborhood (600 housing social city) in Laghouat, Algeria. The bloc (J) in this location, suffering from damages that are attributed to the expansive clayey soil interaction with sewage disposal under foundations was the subject of rehabilitation in this study.

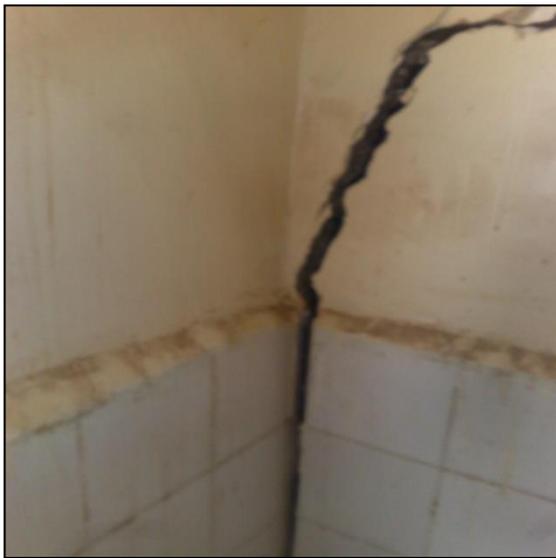
a) Inside

The bloc (J) consists of sanitary basement, ground commercial floor and three floors for residential use as shown in Figure 2. The visual inspection of the structure revealed evidence of cracking of external and internal walls of first and second floors. Some photographs showing the current state of cracks inside and outside bloc (J) building are presented in Figure 3. Most of the cracks in the building were found to be at the internal walls of first and second floors.

Fig 3. State of cracks inside and outside bloc (J) building.

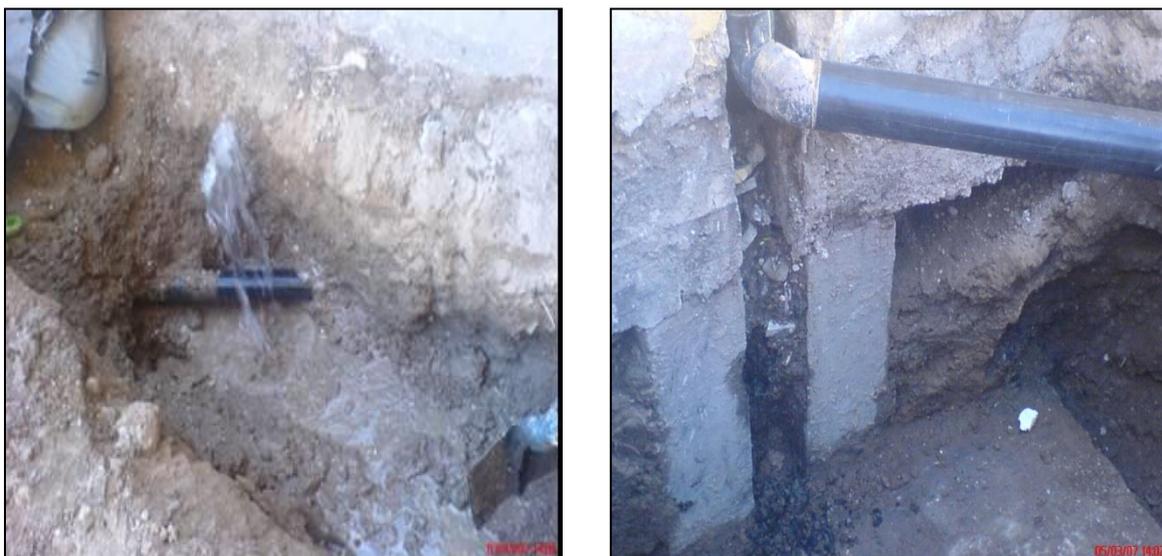
The main sanitary sewer system of the building is located in the basement and collects wastewater from the floors sewers. Blockages in the building sewer can cause backups of sewage toilets, showers and floor drains. These types of blockages are sometimes referred to as basement backups, which can lead to disease, destruction of valuables and damage of building property. Damages in the building sewers system have been located in the basement of the studied building, which causes infiltration of wastewater through cracked pipes (Figure 5).

Fig 5. Infiltration of wastewater through cracked pipes.

The first step to repair the damages is repairing building sewers. The solution consist on performing an inspection of wastewater utility, prior any repair, to identify if there is a problem in floors sanitary sewer pipe system. After this preliminary inspection, the main sewer manhole located in the interior of building (in basement) is changed to the exterior, before the main sanitary sewer in the street, to avoid any wastewater infiltrations around the foundations (Figure 6).

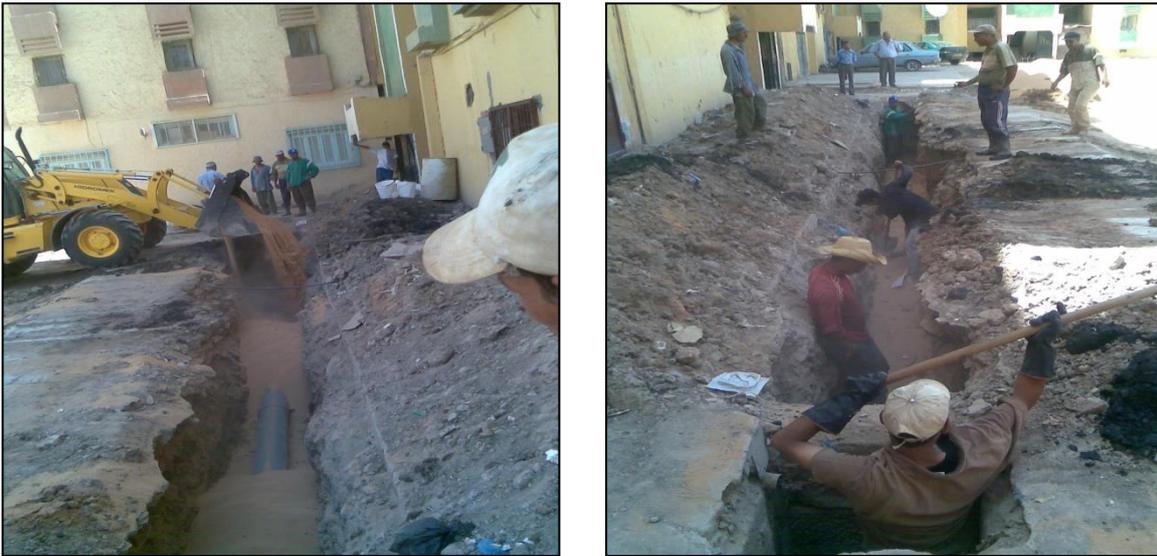
Fig 6. Main manhole sewers were moved completely outside the building.
