## Pathology, Evaluation and Repair of Bridges in Masonry

Rehab Bekkouche S <sup>1,\*</sup>, Boukhatem G <sup>2</sup>, Mendjel D <sup>1</sup>, Messast S <sup>1</sup>

## 3. The case study: the bridge on river Kentra Stora Skida (North-East of Algeria)

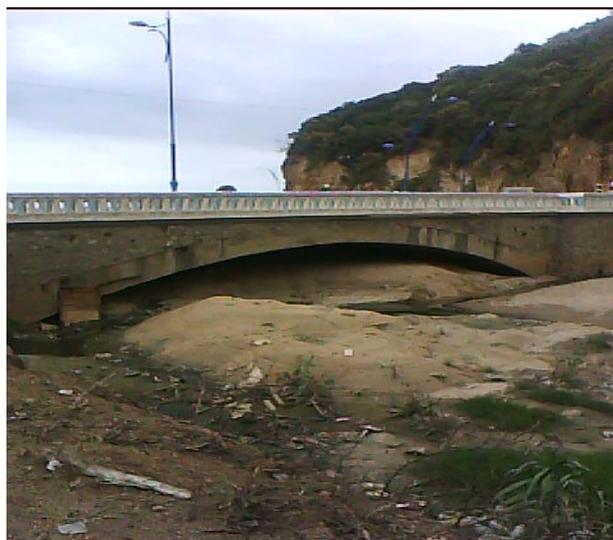
The presence of significant cracks on the entire structure: The slab of the deck also has significant delamination areas in addition to having a thickness insufficient by standards. The vault and the abutment show traces of water infiltration. The bursting of concrete with stripping and corrosion of the reinforcement at the cornices. Cracks are also visible on the masonry in Fig. 2. They usually run along the joints. Locally, splinters between the rubble are also visible.

The cracking developed is due to the presence of microcracking in the mass of the mortar and to the weaknesses of the stone - mortar interface (Stablon, 2011).

**Fig 2. Bridge over the River river Kentra Stora, in Skikda.**

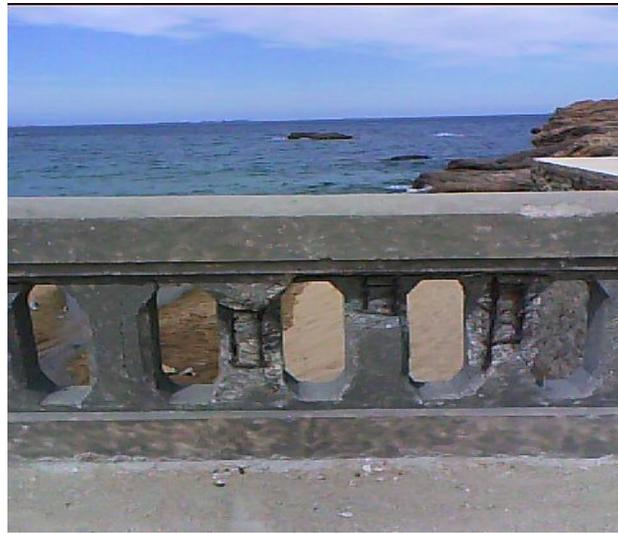
As the bridge is located in an area close to the sea, special attention has been paid to this factor in order to limit the problems and damages related to this environment (Fig.3 and Fig.4).

**Fig 3. Defects affecting the reinforcing concrete.**

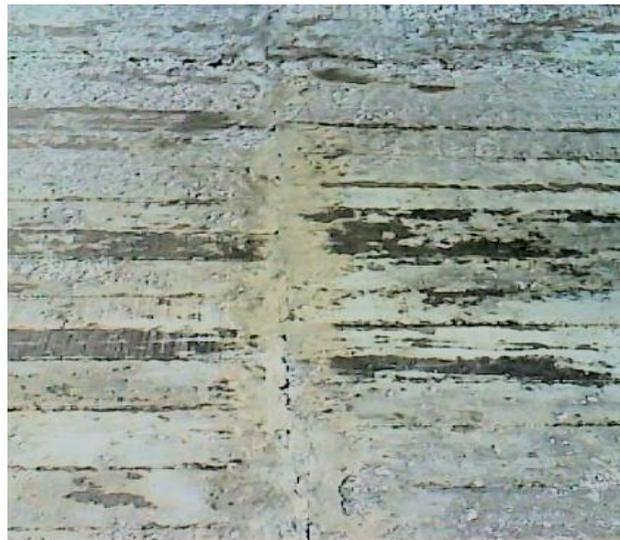
**Fig 4. Cracks and stains on the surface.**

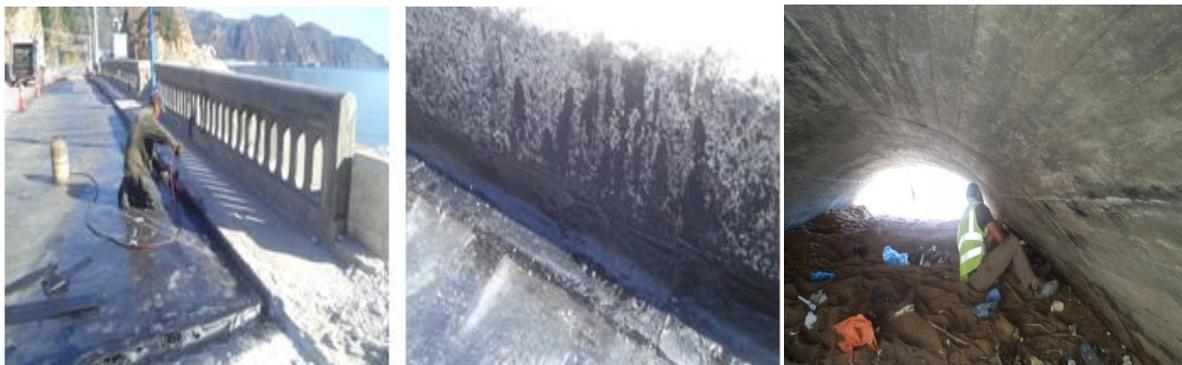
**Fig 5. Bridge Repair Works.**

Apart from the deteriorations observed, our structure is in an "acceptable" state from the point of view of mechanical functioning. Thus, we offer maintenance and repair of degraded parts of the work (Fig. 5 and Fig. 6), this work which lasts approximately two months and essentially comprises the following stages:

- Paved body debris on a thickness of 30 cm.
- Realization of a screed of 5cm concrete cleanliness.
- Realization of a slab (high seal) to the right of the 15cm structure with reinforced National road 27 concrete mesh welded after cleaning, surface preparation and all subjections of good execution.

- Implementation of a sealing complex.
- Implementation of an asphalt concrete wearing course (8cm thick).
- Washing masonry and reinforced concrete facings with pressurized water (6 bars).

- Stitching and blowing in the compressed area of degraded concrete surface (Corniche + Railing) with energetic brushing of exposed steel.
- Repair of degraded concrete (cornice + guardrail) with hydraulic mortar based on resin emulsion, including primer primer on any thickness <5cm.

- Injection of fissures with the resin (SIKADUR 52 or equivalent).
- Sanding of railings.
- Applying layers of paint on railings

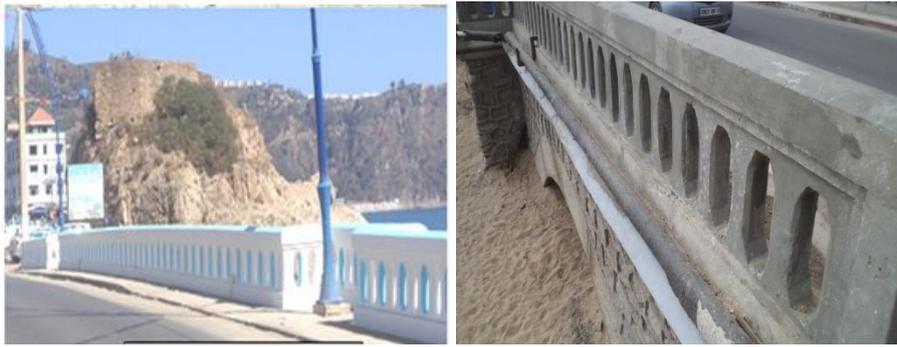
**Fig 6. Bridge after rehabilitation Works.**
