**Architecture in Southern Algeria: A Study on the Factors and Causes of its Collapse and the ways of its Preservation:
Ksar Melouka “Melouka Palace” as a Model.**

Mansouri M'hammed Nour Bachir University Center of El-Bayadh

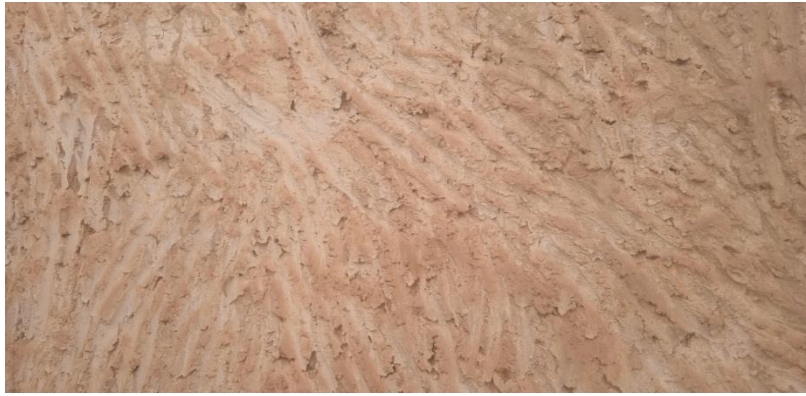
Walls are built with composite bricks, sometimes in an orderly manner and sometimes irregularly. Their thickness varies from one wall to another, decreasing as their height increases. At the base, the thickness reaches 1 meter and gradually decreases to 15 centimeters as the walls rise. When the walls reach the surface level, they serve only as enclosures. The bonding material is mortar, which varies according to the wall type. To plaster the walls with mud mortar, builders use a flat wooden piece, and sometimes even their hands, leaving visible traces on the walls, as shown in the following image.

figure 01: The image illustrates the use of hands in plastering the walls.

Builders used a thread to achieve straight walls.

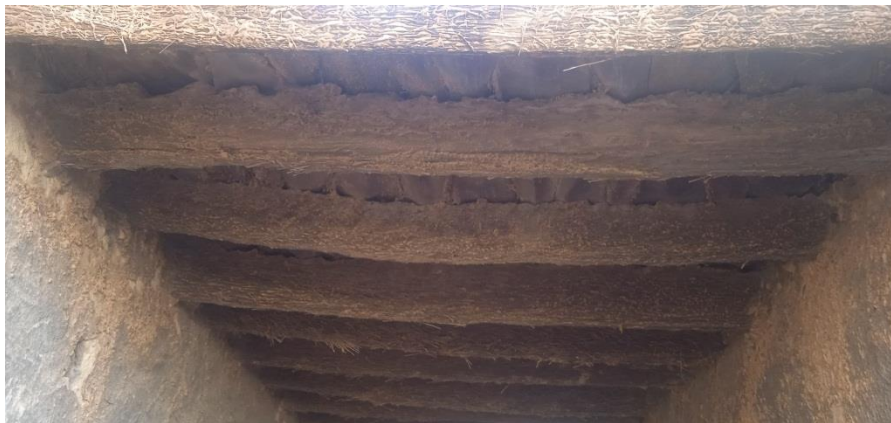
Palm trunks were used in the roofing technique of the palace due to their abundance. The roof takes the shape of the covered area, with a series of prepared wooden pieces placed vertically on the walls, spaced equally apart. Then, the leaf bases (*Kurnaf*) are placed on top of them, as shown in the following image.

figure 02: The image illustrates the technique of roofing with palm wood.

Afterward, it is covered with palms fibers or worn-out clothes, then the whole structure is covered with clay. Afterward, it is polished to create a smooth layer. In building this type of roof, it is important to ensure its slope towards the roof gutters "*mizeb*" to prevent water accumulation. In this technique, the length of the room does not exceed three meters based on the length of the palm wood. The thermal insulation increases with the

thickness of the clay material used above the palm wood, but it should not exceed 40 cm to maintain its compatibility with the load-bearing capacity of the wood for this thickness¹³.

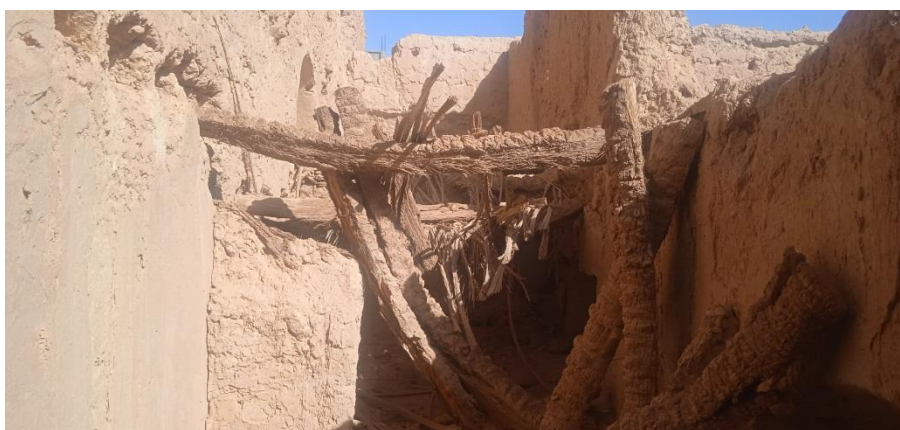
Due to the fact that palaces “*Ksour*” are located in a desert environment where rainfall is rare, it is seldom discussed; however, this does not prevent us from addressing this factor. The building materials used in these monuments are highly affected by rainwater, which works to disintegrate the building materials and can directly penetrate the roofs of the buildings and their various elements. This is especially true considering that rainfall in these areas can be sudden and sometimes heavy, lasting for periods of up to 48 hours. It often leads to the collapse of many buildings, and rainwater frequently manages to infiltrate buildings through the gaps between walls and windows, as well as through the porous nature of the building materials and the roof surface. The following image illustrates this:

figure 03: The image illustrates the effect of rainfall on *Kasr Melouka*.

Water is considered the main and principal factor in deteriorating the buildings built with soft bricks, because the increase of water provokes the total separation of clay’s minerals and moving them from their places. This case happens directly when the buildings are exposed to heavy rains, and happens indirectly when rain water is flowing on their walls¹⁸.

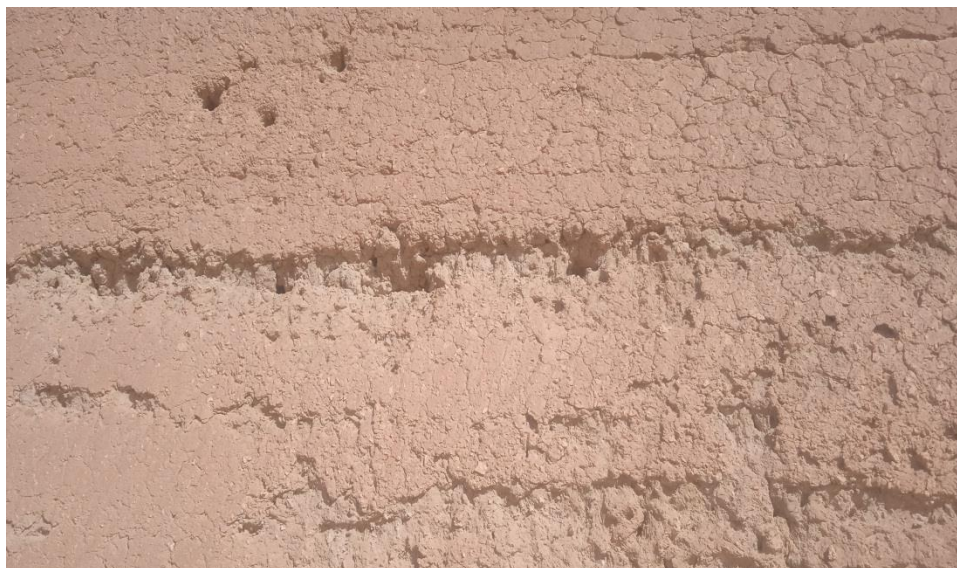
Winds contribute to the burial of buildings and archaeological elements with soil and sand, exerting pressure on them. They also work on sculpting and disintegrating walls, often resulting in walls and rocks standing on sharp edges as a result of this phenomenon²². Additionally, they contribute to the deterioration of buildings made of soft bricks, which is an important factor directly affecting them, primarily through the phenomenon known as sandblasting²³, as illustrated in the following image:

figure 04: The image illustrates the impact of wind on the northern wall of *Kasr Melouka* **Source:** The researcher.
