Rehabilitation of existing building structure in expansive soils: A case study in Laghouat, Algeria

Abstract. This work presents results obtained from a case study conducted on M'kam neighborhood (600 housing social city) in Laghouat, Algeria. The bloc (J) in this location, suffering from damages that are attributed to the expansive clayey soil interaction with sewage disposal under foundations was the subject of rehabilitation in this study.

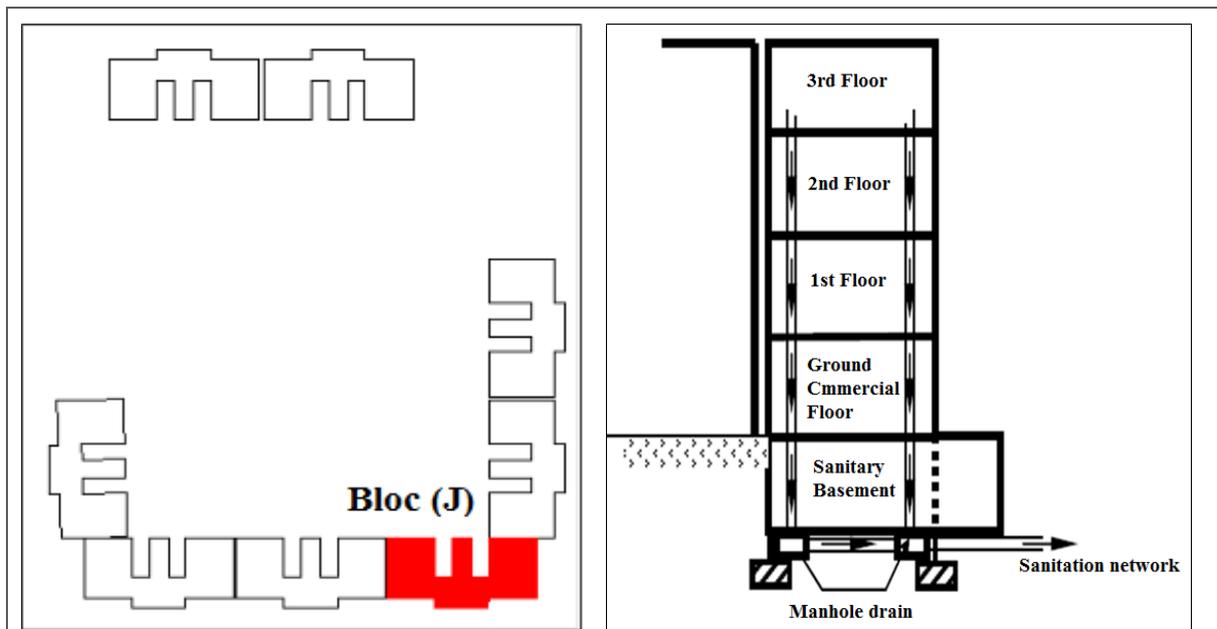
The bloc (J) consists of sanitary basement, ground commercial floor and three floors for residential use as shown in Figure 2. The visual inspection of the structure revealed evidence of cracking of external and internal walls of first and second floors. Some photographs showing the current state of cracks inside and outside bloc (J) building are presented in Figure 3. Most of the cracks in the building were found to be at the internal walls of first and second floors.

Fig 2. Situation and general structure of Bloc (J) building.

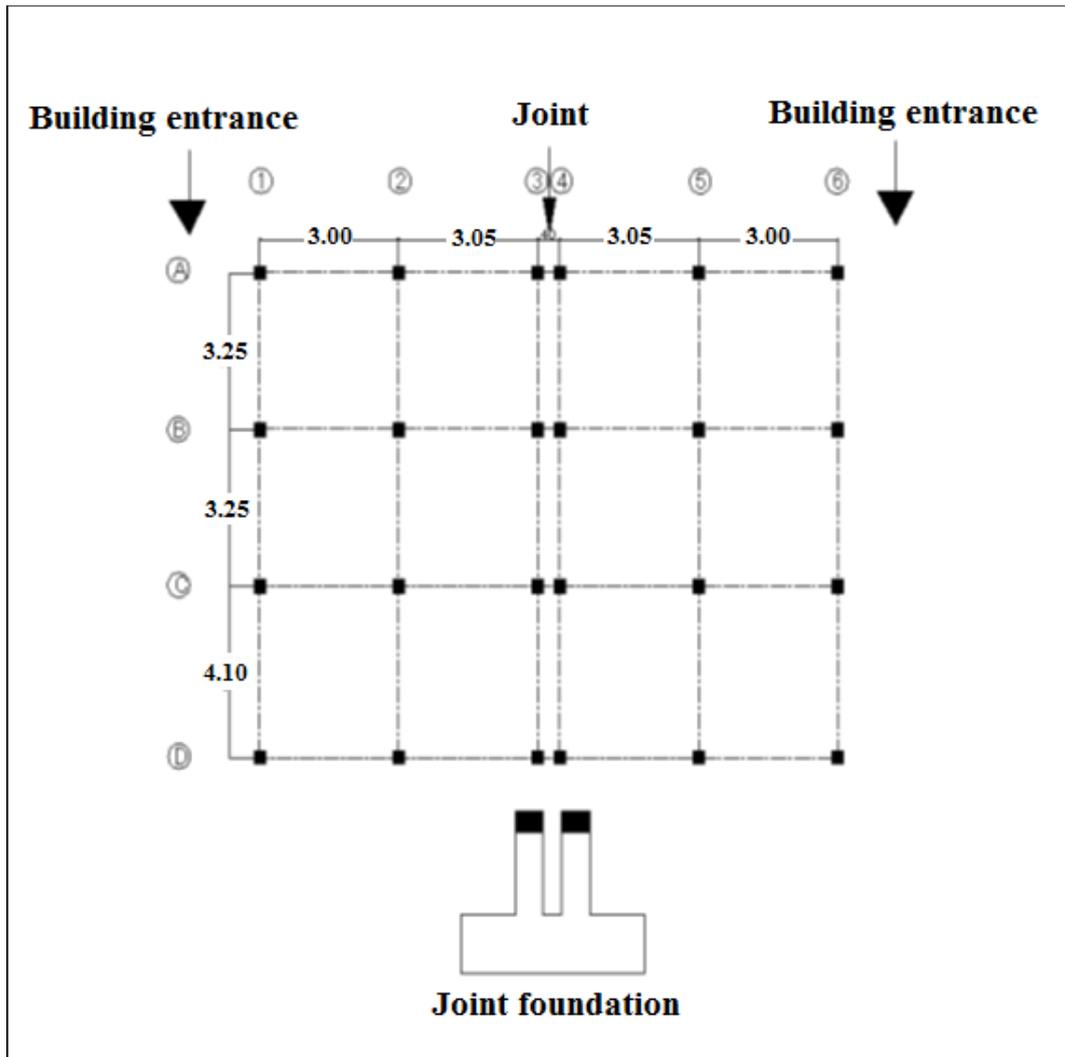
The foundation of the studied building is of the superficial type, it is formed of insulated soles bonded by stringers. These soles are placed on a massive concrete. The foundation plan of the studied building is presented in Figure 4.

Fig 4. Foundation plan of the building.

stability of the building and to correct the expansion joint openings caused by the differential movement of the foundations, reinforced concrete footings with peripheral sails were installed on both sides of each expansion joint along the total building basement height (Figure 7).
